In-bore Detonation of Non-standard Ammunition,
Testing a Russian T-55 Tank

Steven J. Reeves and Ralph Scutti

In-bore Detonation of Non-standard Ammunition

July 2010

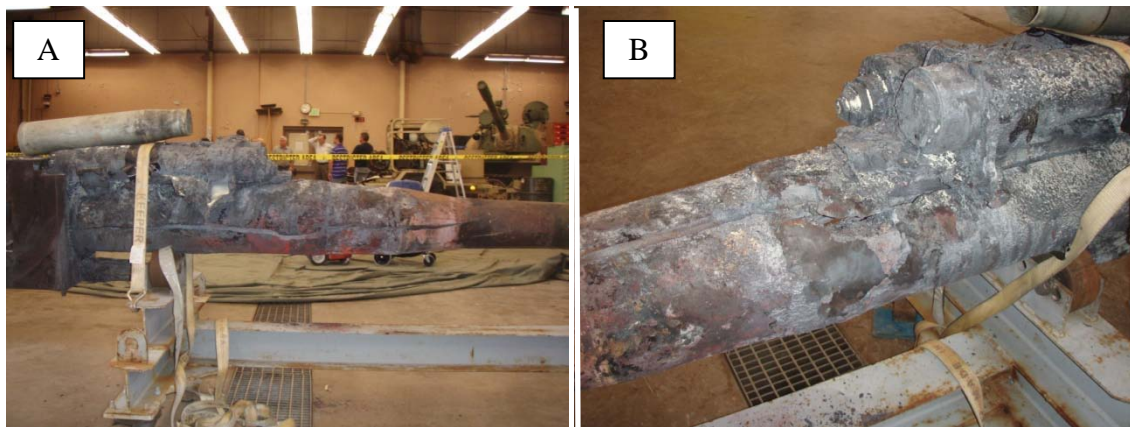
Figure 1 Failed 100-mm gun tube after incident, 65” and 60” long cracks in images A and B respectively

The final report titled; Evaluation of Failed 100-mm T55 Soviet Tank Cannon, August 2009 concluded ‘Through Benet Laboratories failure analysis and interior ballistics simulations the gun tube could safely fire the BK5M HEAT round. The accident was caused by the BK5M HEAT round detonating in the tube. A reason for the premature detonation is unknown and part of an ongoing investigation. The projectile was at or near maximum acceleration when the event took place.’ The report also stated in the summary; ‘Failure mode of the tube is fast fracture due to an overpressure situation, Projectile travelled approximately 16 inches prior to the event, Tube material had adequate strength to support firing of the HEAT round under normal conditions, The chamber pressure at the time of the accident was 3000 Bars, The residues examined from the bore surface were determined to be rust, brass and elements found in the primer, and The projectile was fired and began to move’.

5) The failure analysis performed by Benet Laboratory concluded that the projectile moved approximately 16 inches down the tube before detonating. Additionally Benet concluded that the gun tube did not fail due to fatigue or wear but rather due to an event (force) that it was not designed to contain.

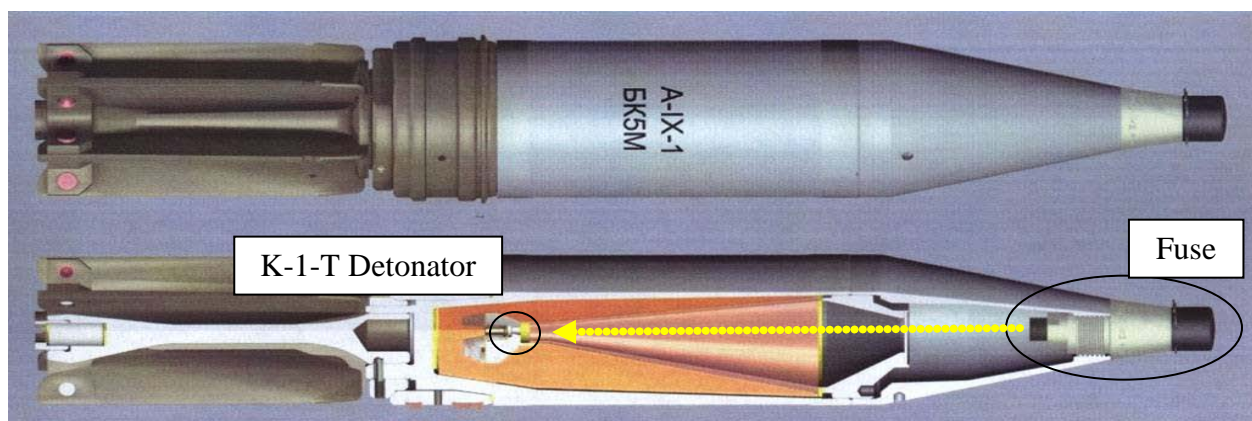
Two of the BK5M warheads were examined in October 2008 to determine if the high explosive could be removed. Removal of the projectile’s high explosive main charge was determined to not be feasible due to the design of the projectile and equipment limitations. The HEAT round uses a ‘spit-back’ explosive detonating train to initiate the high explosive main charge. When armed, the GPV-2 fuse at the tip of the round (fig 2) is crushed upon impact with the target. This causes the pezio-generator (fig 3) to generate an electrical pulse sufficient to initiate the electric detonator (fig 3), initiating the fuse explosive train. The fuse detonator (fig 3) fires down the center of the copper cone (fig 2) and ignites the K-1-T base detonator (fig 2) in the body of the projectile. The K-1-T detonator is integral to the high explosive, preventing safe removal of the high explosive main charge.

Figure 2 Projectile, Russian BK5M 100-mm HEAT

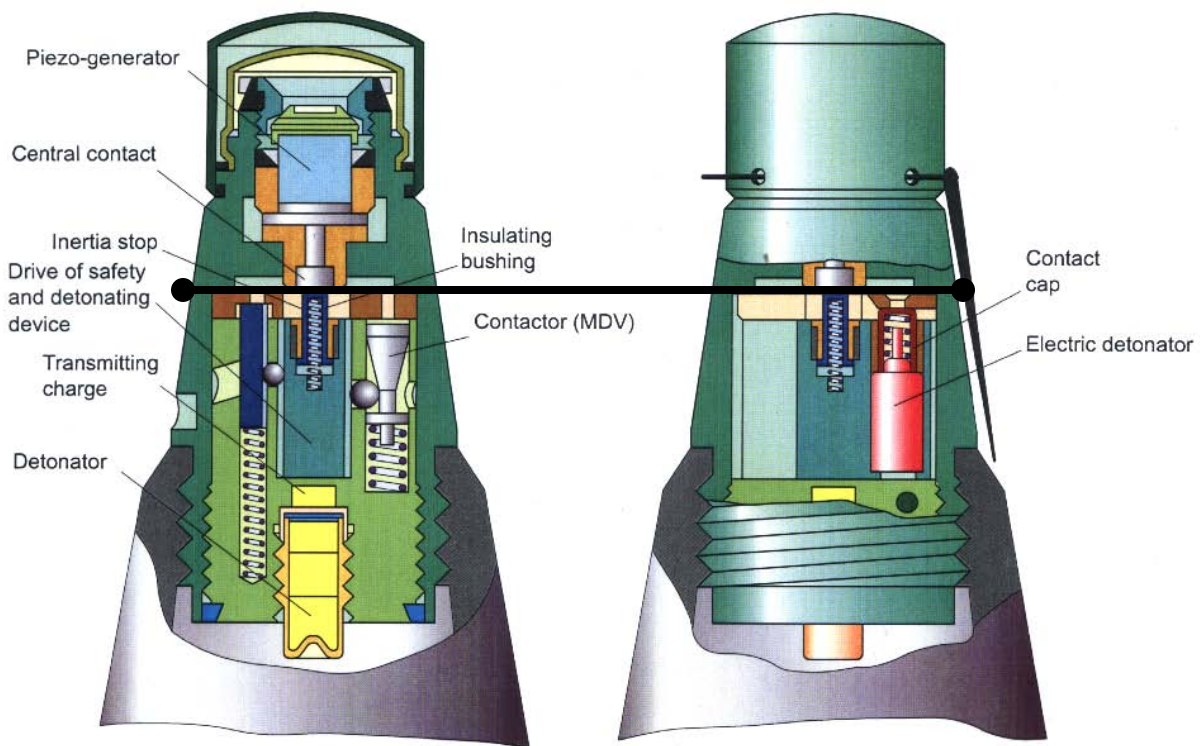
Figure 3 Fuse, GPV-2 for the Russian BK-5M 100-mm HEAT projectile (shown as received).
Modification, all internal components below black line were removed

Since the high explosive could not be removed to totally inert the round the GPV-2 fuse was modified in an attempt to make the projectile less likely to detonate prematurely. The safe and arming mechanism was removed from the GPV-2 fuse, leaving only the pezio-generator and central contact in the fuse. All energetic materials were removed from the GPV-2 fuse. All of the components under the black line (fig 3), the safe and arming mechanism, were removed. The group that performed the modification had documentation indicating that all fuses were modified and all material removed from the fuses was destroyed.

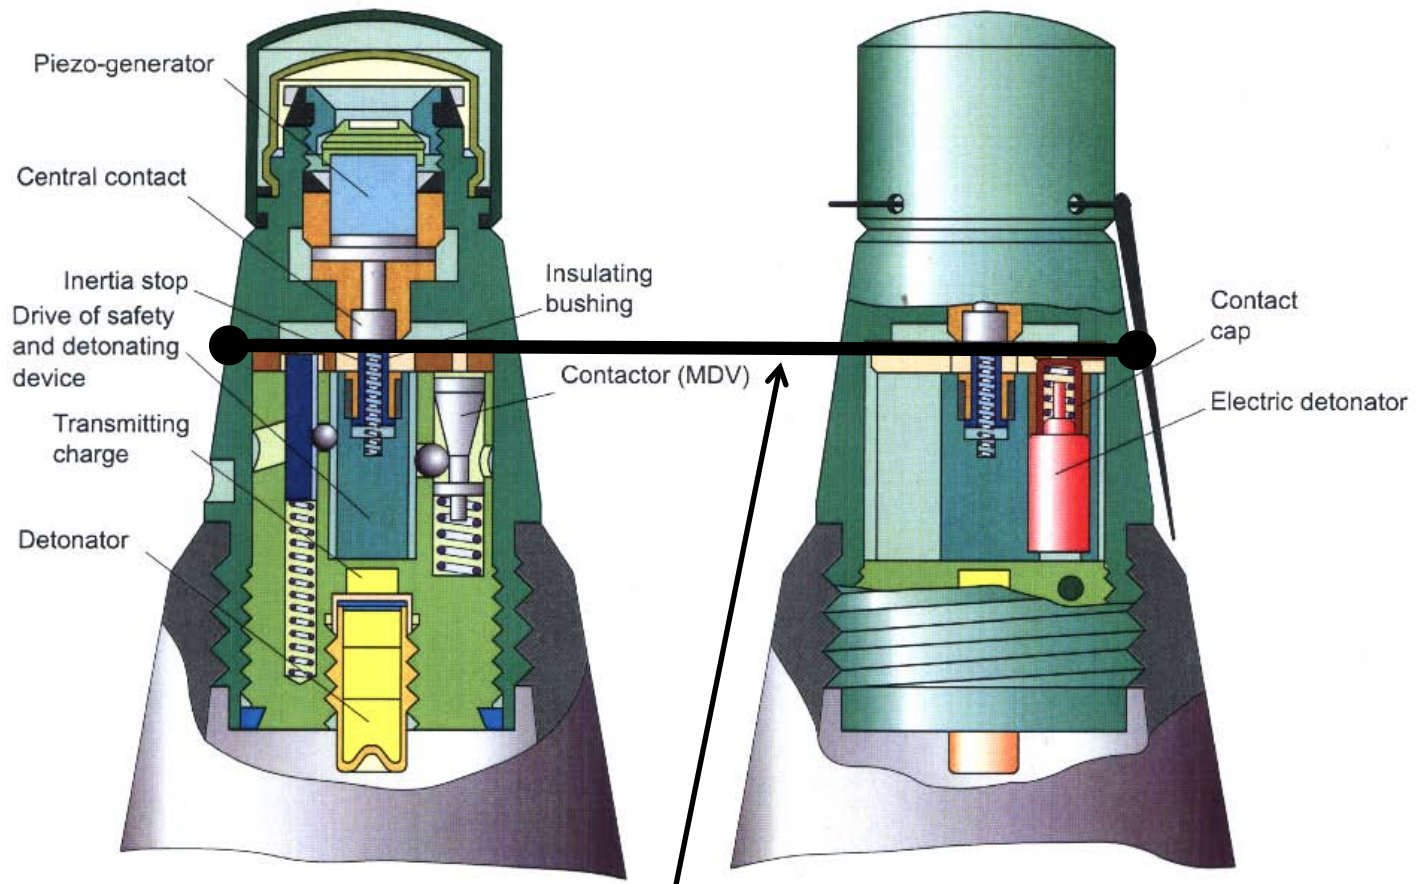
GPV-2 Fuze

Modification Line
